Manhole Inspection Summary

Manhole # S21QQ1004MH

Insp Date: **6/2/07 10:37 AM**

Location Address: **POLYTECH HIGH SCHOOL**

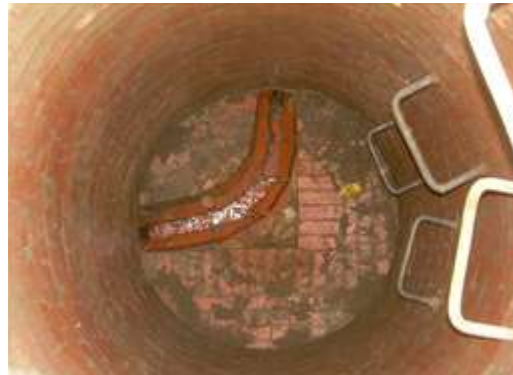
Top View

☐ Parged ☒ **Debris** (not Condition related)

Bench debris.

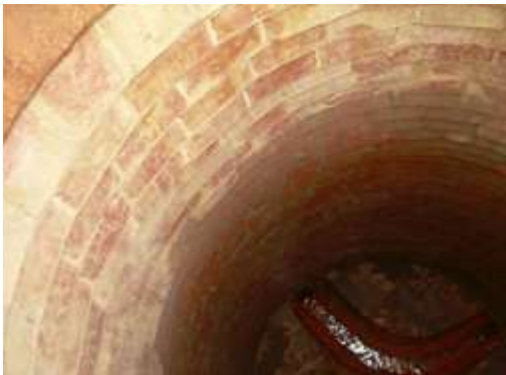
Defect

☒ **Leaks**

Infiltration: ☐ None ☒ **Joint** ☐ Cracks ☐ Mortar ☐ Roots ☒ **Wall**

Infiltration: ☐ None ☐ Joint ☐ Cracks ☐ Mortar ☐ Roots ☒ **Wall**

Adjustment, Corbel and Barrel infiltration.

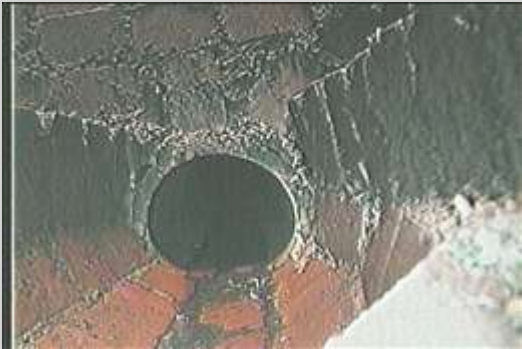
6 in. Circular Gravity Sewer Pipe Out @ 12 O'Clock

Pipe Material: **Clay** ☐ Pipe Lined

Invert Depth: **9.84** (ft.) Flow Characteristics: **Slow**

Deposits: ☒ None ☐ Mud ☐ Sludge ☐ Debris ☐ Grease

Infiltration: **None** Pipe Seal Cond: **Unknown**

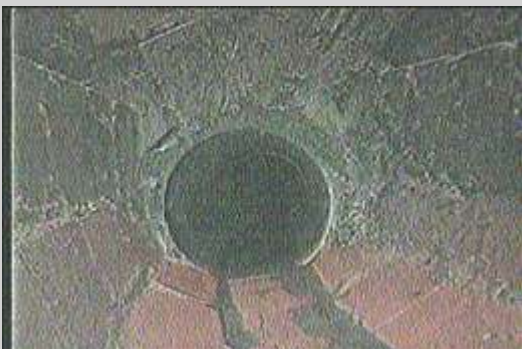
6 in. Circular Gravity Sewer Pipe In @ 9 O'Clock

Pipe Material: **Clay** ☐ Pipe Lined

Invert Depth: **9.59** (ft.) Flow Characteristics: **Slow**

Deposits: ☒ None ☐ Mud ☐ Sludge ☐ Debris ☐ Grease

Infiltration: **None** Pipe Seal Cond: **Unknown**
